## INSTALLATION INSTRUCTIONS

### Thru-Hull Sensor in a Cored Fiberglass Hull

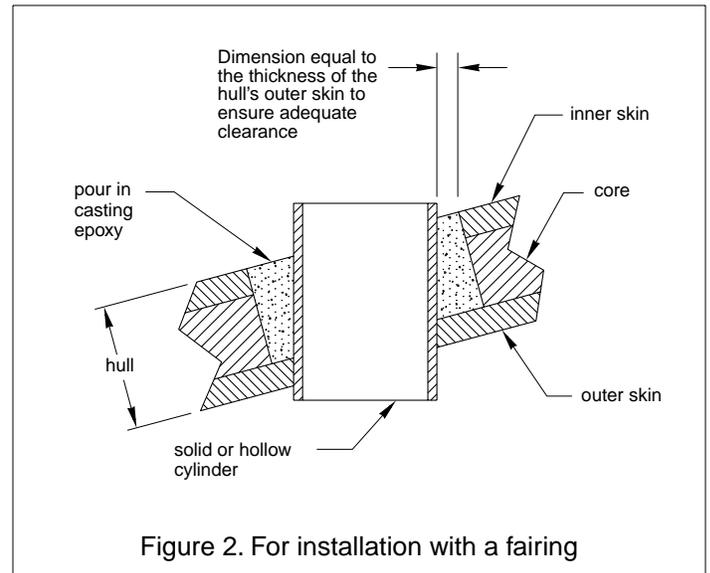
Figure 2. For installation with a fairing

1. Drill a pilot hole from inside the hull (see Figures 2 and 3). For installations with a fairing, drill perpendicular to the waterline. If there is a rib, strut, or other hull irregularity near the selected mounting location, drill from the outside the vessel.

Alternatively, a hollow or solid cylinder of the correct diameter can be coated with wax and taped in place. Fill the gap between the cylinder and hull with casting epoxy. After the epoxy has set, remove the cylinder (see Figures 2 and 3).

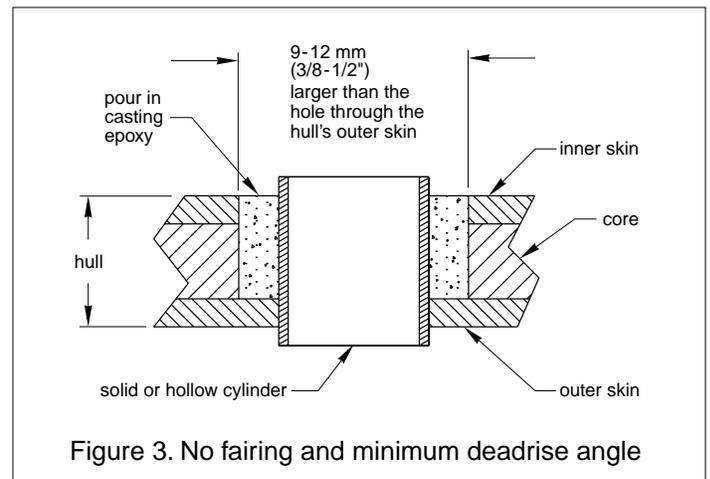
Figure 3. No fairing and minimum deadrise angle

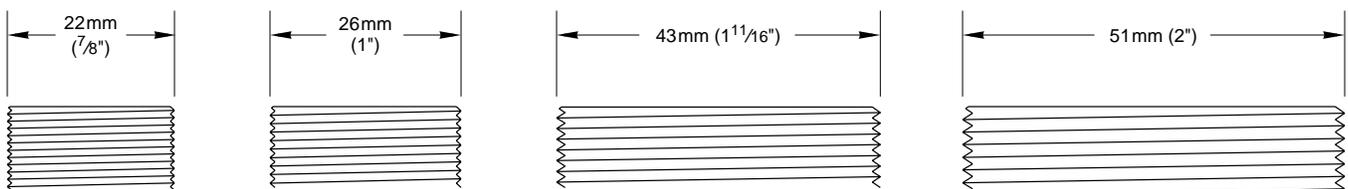
Figure 1. Diameter of the sensor's threaded stem

Drill bit, hole saw, or spade bit for (see Figure 1):

pilot hole: 3mm or  $\frac{1}{8}$ "

22mm ( $\frac{7}{8}$ " diameter threaded stem

exterior hole: 22mm or  $\frac{7}{8}$ "

interior hole<sup>a</sup>: 35mm or  $2\frac{3}{8}$ "

26mm (1" diameter threaded stem

exterior hole: 26mm or 1"

interior hole<sup>a</sup>: 38mm or  $1\frac{1}{2}$ "

43mm ( $1\frac{11}{16}$ " diameter threaded stem

exterior hole: 43mm or  $1\frac{3}{4}$ "

interior hole<sup>a</sup>: 54mm or  $2\frac{1}{8}$ "

51mm (2" diameter threaded stem

exterior hole: 51mm or 2"

interior hole<sup>a</sup>: 60mm or  $2\frac{3}{8}$ "
